## **A Planning Perspective on Fire Hazard Vulnerability of Shopping Centers in Dhaka City: A Case Study Base Approach**

**S. M. Nawshad Hossain\***  
**Saiful Islam\*\***

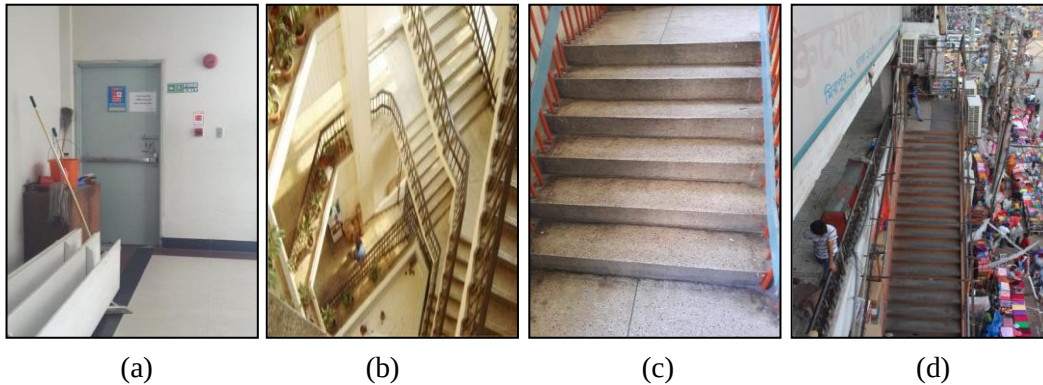
**4. Emergency Exit:** It provides a method of escape in the event of a fire or other emergency that makes the stairwells inside a building inaccessible. From field survey, it is observed that, in Bashundhara City Shopping Mall there are 3 emergency exits, in Eastern Plaza and Motalib Plaza there is one emergency exit, where as in Muktijoddha Super Market there are two emergency exits. The emergency gate of the Bashundhara City Shopping Mall is blockade by different materials and it is locked by the authority. In Motalib Plaza the emergency stairs is so narrow and sloppy. As a result during the fire hazard accident time, the people cannot move easily. In Eastern plaza, different types of waste are thrown in emergency exits and here Open stair will be a carrier of fire and smoke in Eastern plaza. In Muktijoddha Super Market the emergency exits are made of steel frame and always use as general stairway and these are not wide and strong enough to support during fire accident.

Fig. 3: (a) Locked emergency gate in Bashundhara City Shopping Mall, (b) Open stair will be a carrier of fire and smoke in Eastern Plaza, (c) Sloppy and narrow emergency stairs in Motalib Plaza and (d) Narrow and weak steel frame emergency stair in Muktijoddha Super Market

- Though all case study shopping centers have emergency exit, but either the emergency stairs are lock for all time or very narrow in width. That may hamper the proper function of emergency exits during emergency time.

- **Measures related to Emergency Exit:** According to BNBC 2012 and Dhaka Mohanagar Imarat Nirman Bidhimala 2008, each shopping center should have sufficient provision of emergency exits. But from the field survey, it is evident that the existing emergency exits of the selected shopping centers are not satisfactory at all. If possible, these shopping centers should have to develop more emergency exits to ensure safe escape routes during the time of fire hazard.
